AFFDL-TR-78-95

## LIGHTNING STRIKE SUSCEPTIBILITY TESTS ON THE AIM-9 MISSILE

*TECHNOLOGY/SCIENTIFIC SERVICES, INC.  
AIR FORCE FLIGHT DYNAMICS LABORATORY (AFFDL)  
ELECTROMAGNETIC HAZARDS GROUP (FES)*

TECHNICAL REPORT AFFDL-TR-78-95  
Final Report for Period October 1977 – November 1977

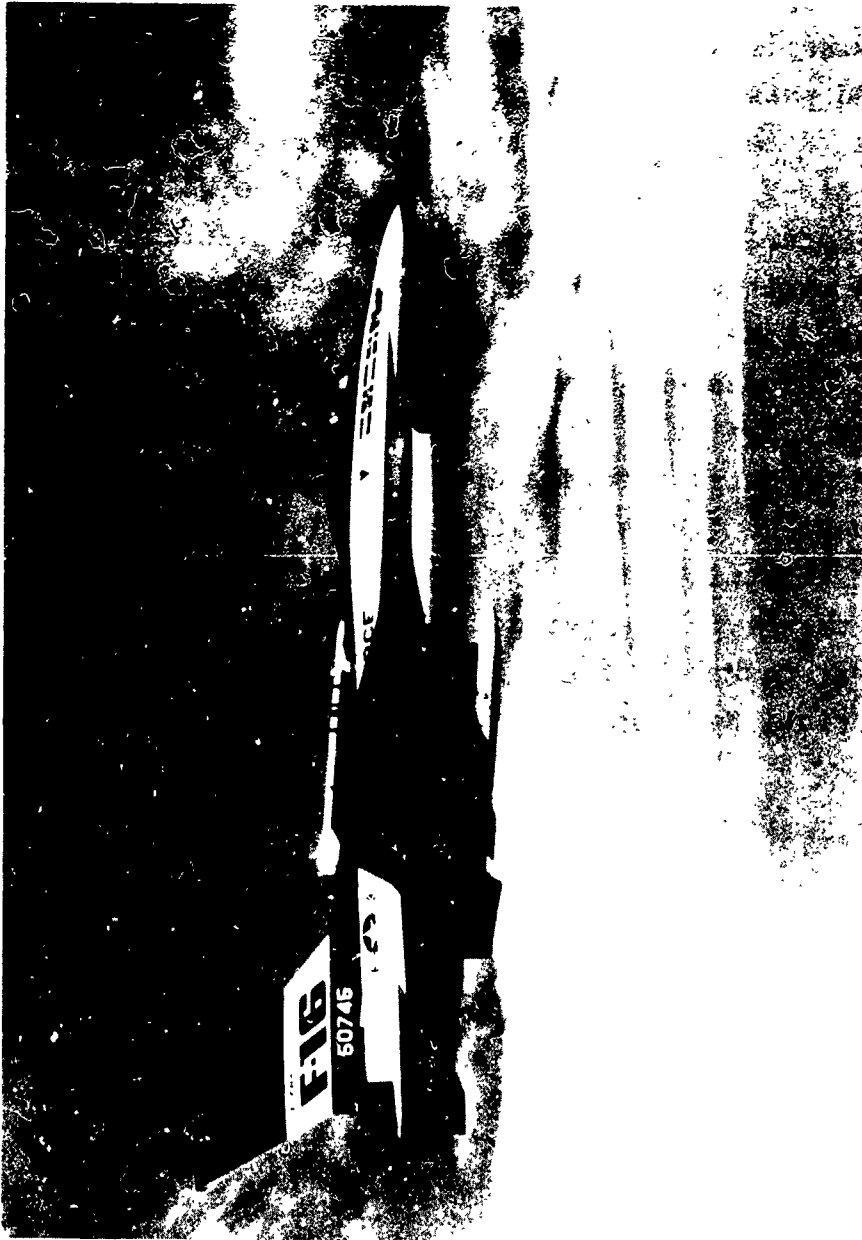
Figure 1. AIM-9 Missiles Mounted on an F-16 Aircraft

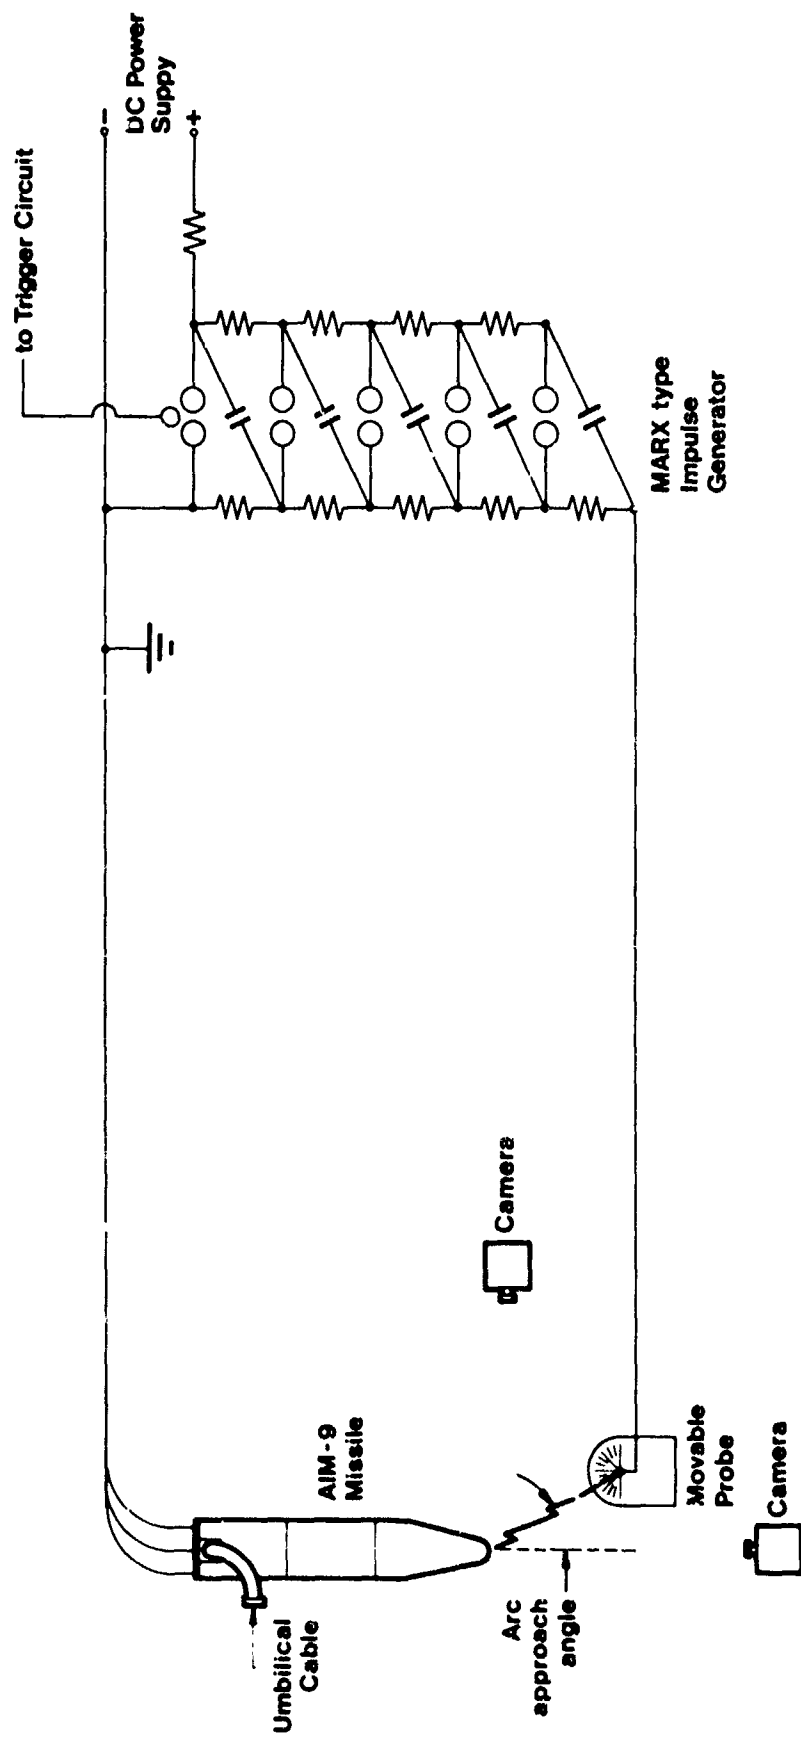
Figure 2. High Voltage Attachment Test Setup

This test was performed to answer questions IIa and IIb and to document the point of attachment of the lightning arc on the missile. To accomplish this, a Marx type impulse generator (Figure 2) with a high voltage peak output of approximately 700 kilovolts generated an arc, one meter in length, to the front part of the missile. The attachment was documented by cameras set at  $90^\circ$  to each other as specified in design note 7C2 of Reference 4.

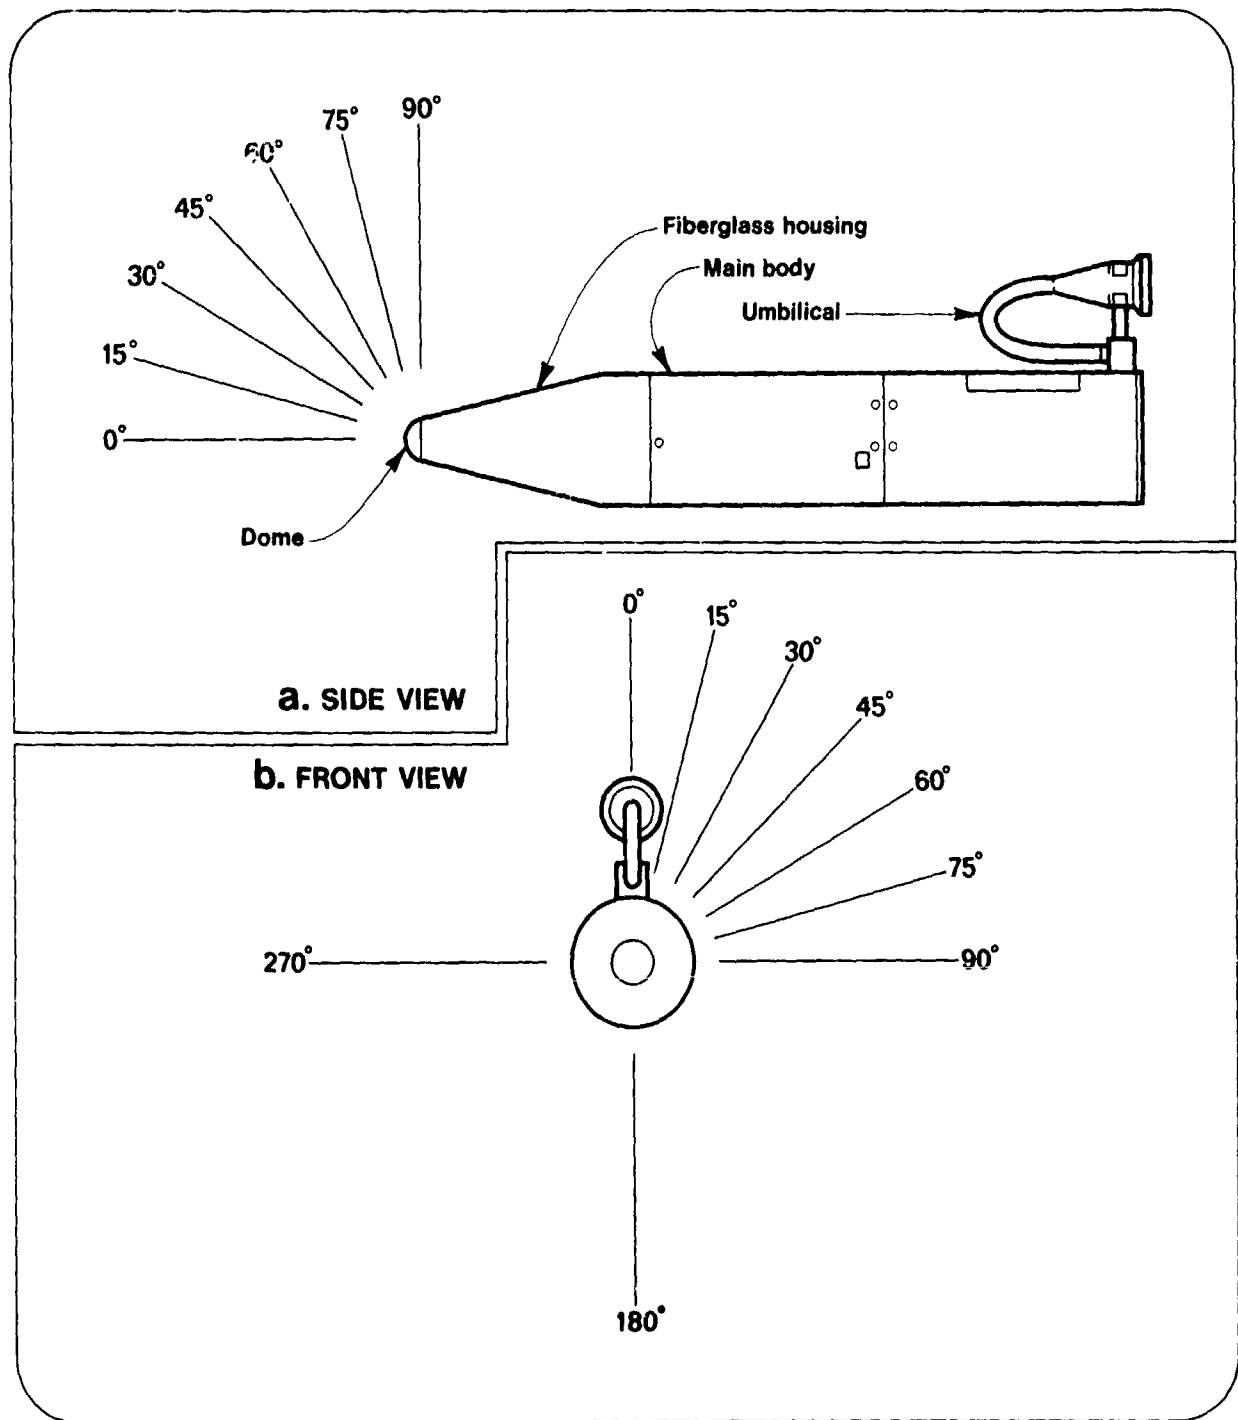
Figure 3. Electrode Locations for High Voltage  
Arc Attachment Tests of AIM-9 Missile  
(Horizontal and Vertical Planes)

To provide information on all possible angles of lightning approach to the missile, the high voltage output electrode of the Marx generator was positioned as shown in Figure 3, providing a  $90^\circ$  sweep at  $15^\circ$  intervals in the vertical and horizontal planes. The  $90^\circ$  sweep is sufficient since the missile is axially symmetric in the planes for which lightning attachment tests were performed.

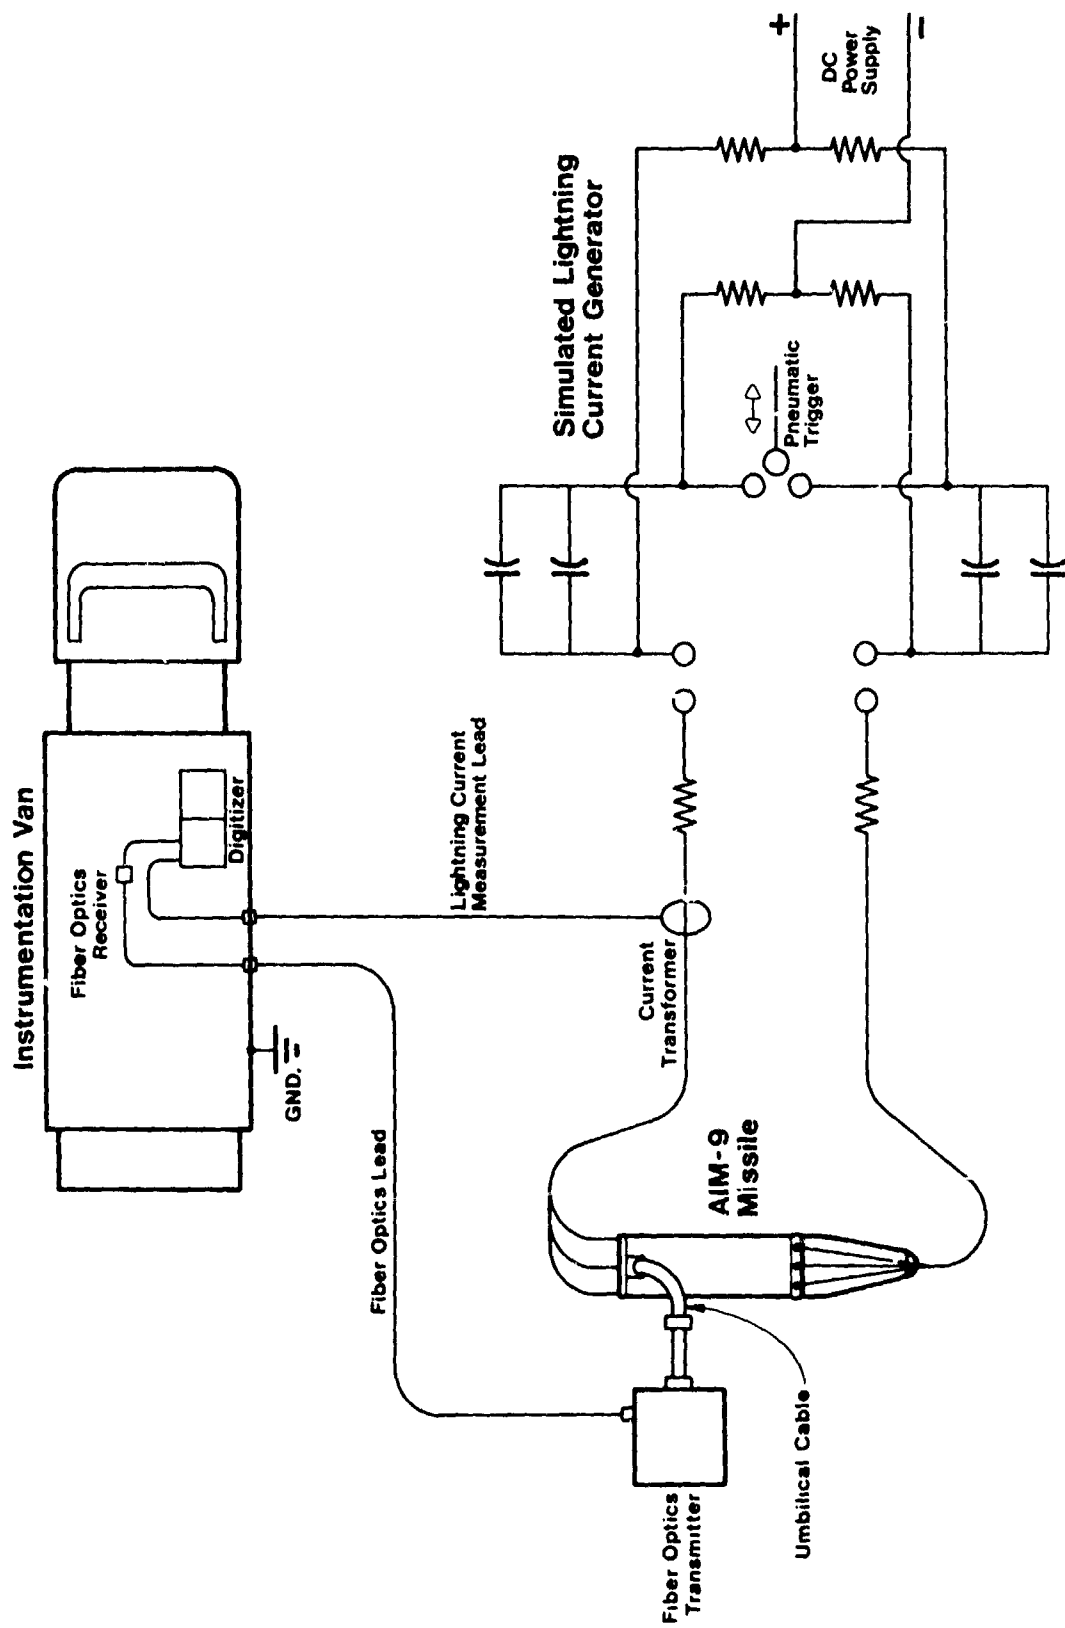
Figure 4. Intermediate High Current Test Setup

the output of a high current impulse generator (lightning simulator), thus preventing external damage. An output current impulse of approximately 12 kiloamperes peak (Fig. 5) was injected along the missile body. Using a fiber optics data link, voltages induced during the test were monitored on selected circuits (based on the findings of Reference 1), inside the missile. Access to these circuits was gained through the umbilical cable on the missile. Figure 4 shows the test setup.

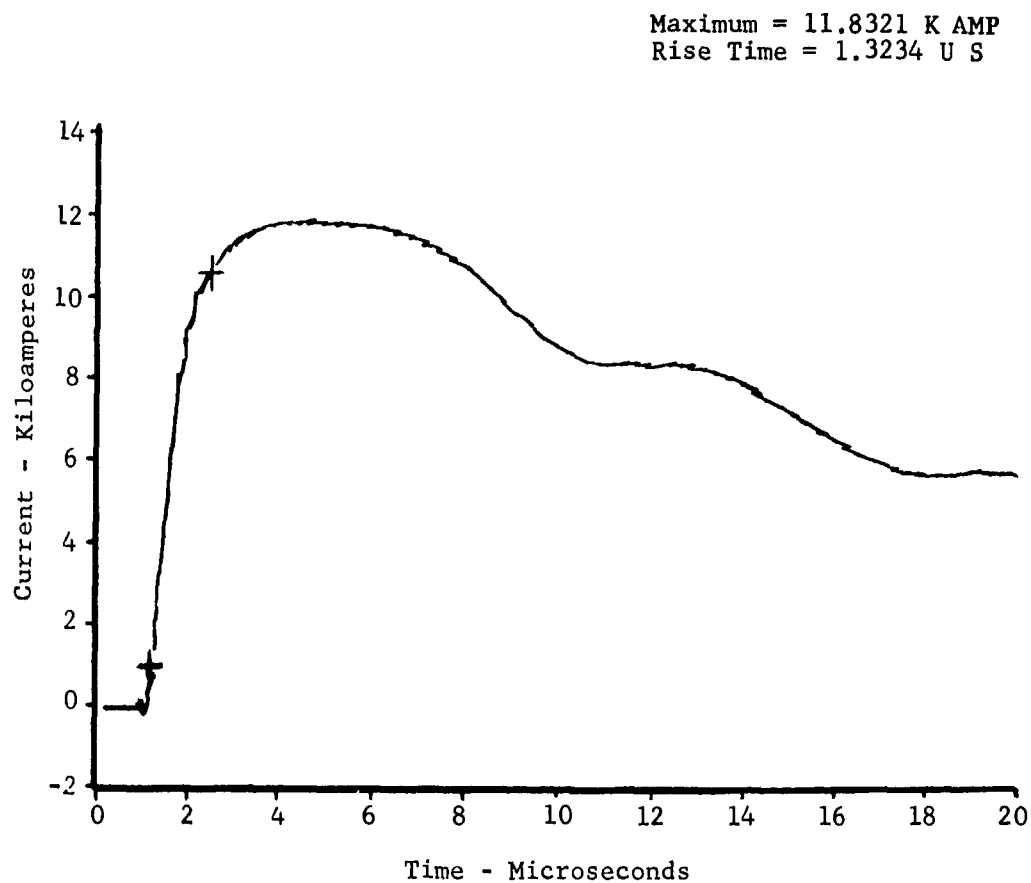
Figure 5. Applied Current Impulse to  
AIM-9 Missile for Induced Effects Measurements

The current impulse applied to the missile for these tests is shown in Figure 5. It had a peak current of approximately 12 kiloamperes with a rise-time of 1.3 microseconds.

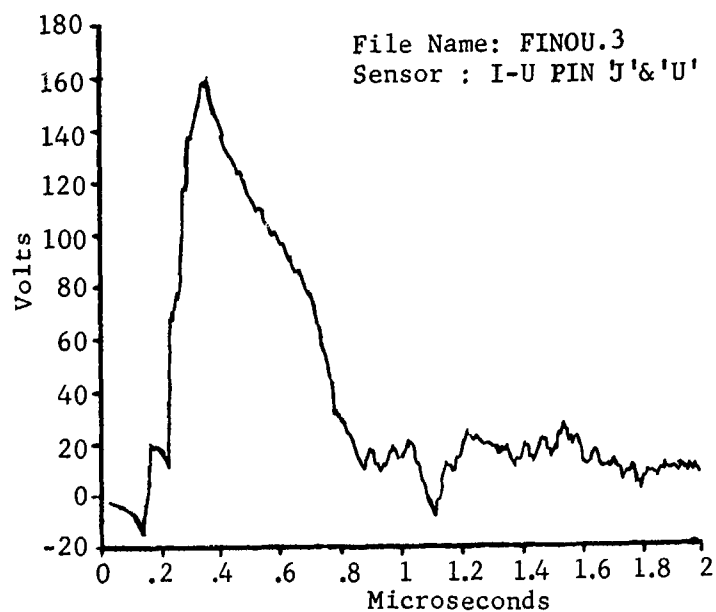
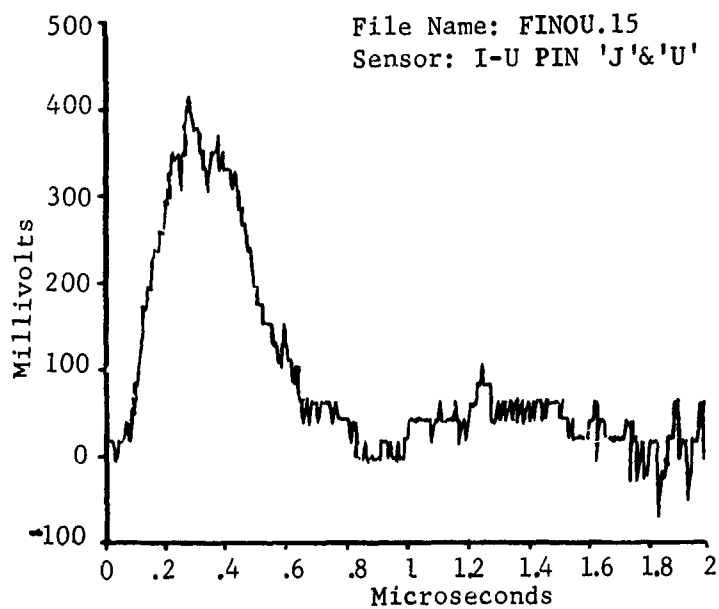
a. Without Shielding

b. With Shielding

Figure 6. Comparison of Induced Voltages on Conductors J - V  
With and Without Shielding on Umbilical Cable

Figure 6 is a comparison of the induced voltage magnitude and waveshape measured on conductors J-V. The large reduction in voltage magnitude (volts to millivolts) due to the addition of foil shielding around the umbilical cable is evident.

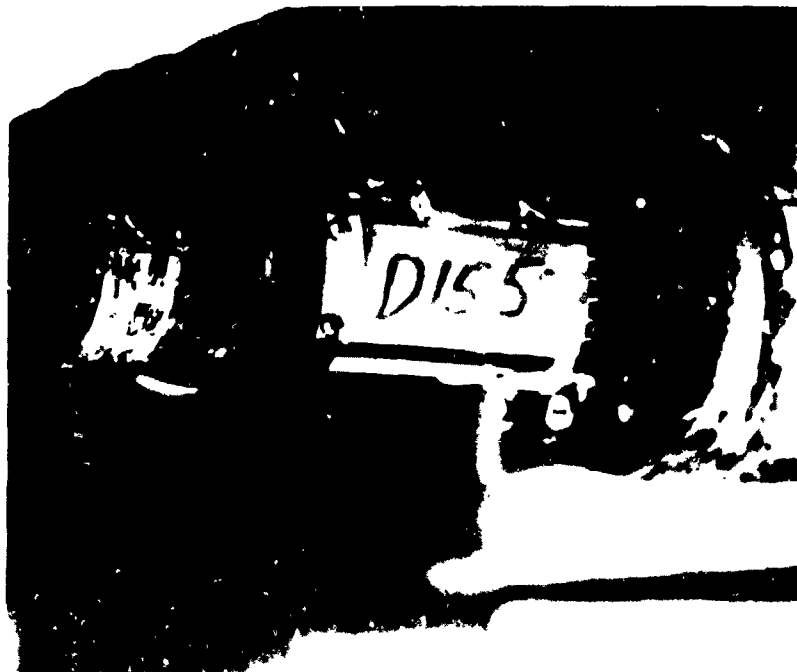
a. Interior of Fiberglass Housing

b. Interior Showing Forward Electronics

Figure 11. Interior of AIM-9 Missile, S/N AJ1355M

Both missiles were disassembled and examined for evidence of internal high current arcing. Figures 11 and 12 show no evidence of arcing on any part internal to the missile. If the simulated lightning currents had entered the missile, via the cracked dome, evidence of arcing would have been found either on the inside of the optical housing, the gyro assembly or on circuit cards. None was found.

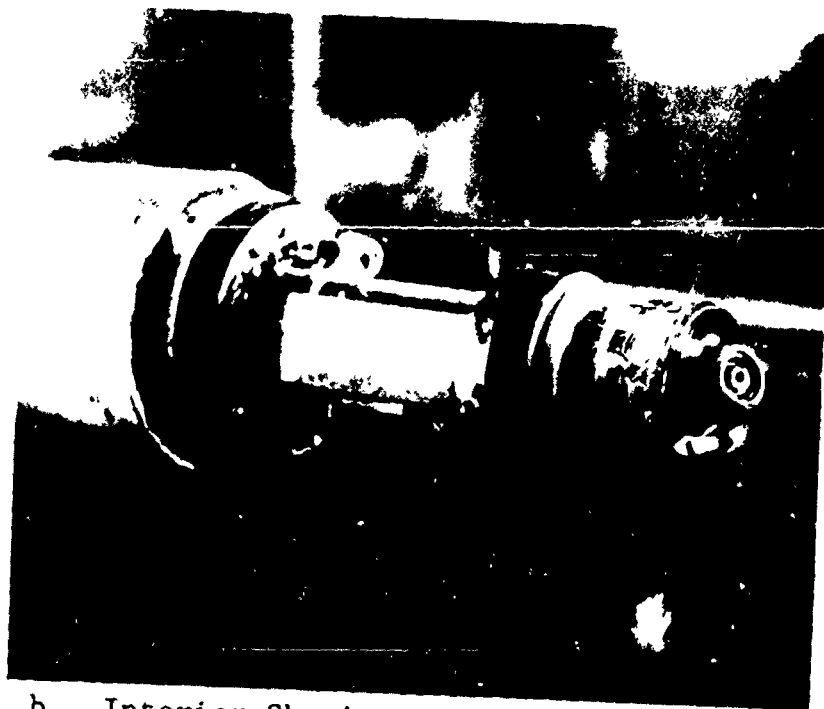
a. Interior of Fiberglass Housing

b. Interior Showing Forward Electronics

Figure 12. Interior of AIM-9 Missile, S/N RLP23372

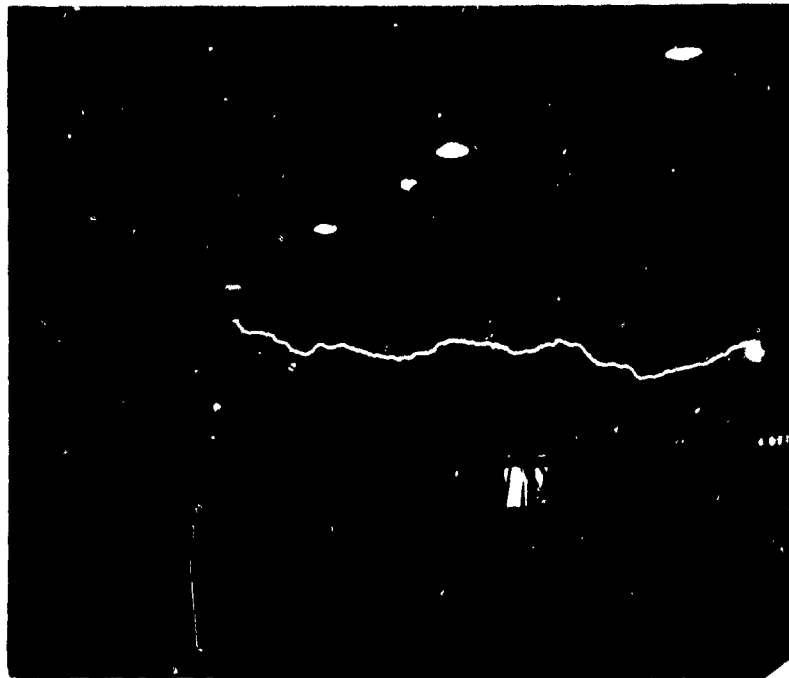
Figure A-2. Arc Attachment to AIM-9 Missile  
Test #2, Probe 90°, Horizontal Plane

Test No	Probe Location		Length of Arc (Meters)	Attachment Point (Approx.)	Figure No	Remarks
	Angle(°)	Plane				
1	90	Horiz	1.0	Dome/fiberglass housing interface	A-1	No noticeable damage
2	90	Horiz	1.0	Dome/fiberglass housing interface	A-2	Pitting at interface, flash-over at fiberglass housing/mainbody interface, burn marks on screws
3	75	Horiz	1.0	Dome/fiberglass housing interface	A-3	Flash-over at fiberglass housing/main-body interface
4	60	Horiz	1.0	Dome/fiberglass housing interface	A-4	Pitting at fiberglass housing/main-body interface, burn damage to screws on backside
5	45	Horiz	1.0	Dome/fiberglass housing interface	A-5	No noticeable damage
6	30	Horiz	1.0	Dome/fiberglass housing interface	A-6	Flash-over and pitting at fiberglass housing/main-body interface, burn damage to screws
7	15	Horiz	1.0	Dome/fiberglass housing interface	A-7	No noticeable damage
8	0	Horiz	1.0	Dome/fiberglass housing interface	A-8	Major burn marks on screws on backside, pronounced burn mark at attachment point

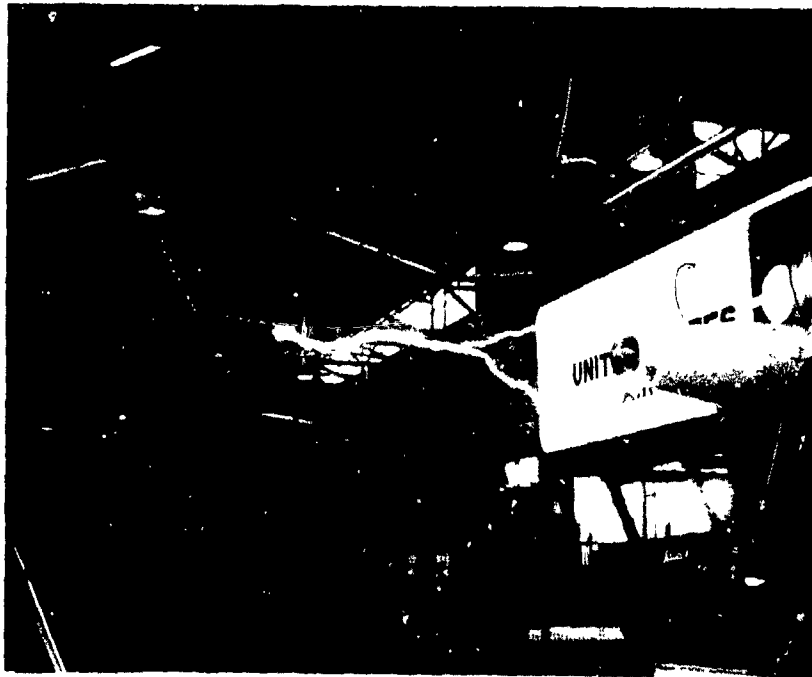
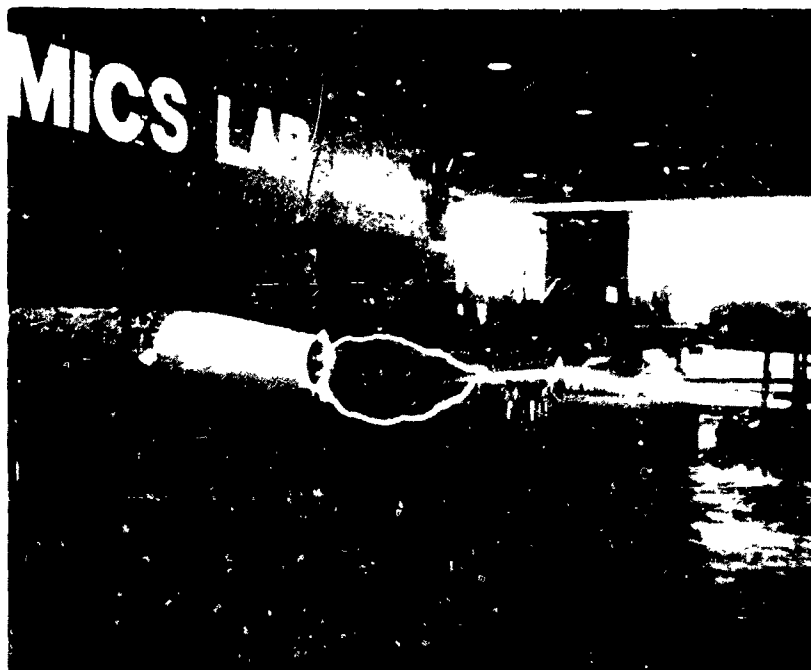
Figure A-18. Arc Attachment to AIM-9 Missile  
Test #18, Probe 0°, Vertical Plane

b. In the one case of attachment to the optical dome there was a surface flash-over to the zinc-coated fiberglass housing, with no penetration of the optical dome. Prior to attachment (Figure A-18) the arcs branched and attached to the dome and to the dome/housing interface.

18	0	Vert	0.51	(Optical) dome and dome/fiberglass housing interface	A-18	No noticeable damage, arc branched and attached to dome at 0° and to dome/housing interface at 180°
